米海軍厚木基地所属F/A-18Eスーパーホーネットからの部品落下に係る
調査報告書について

第115戦闘攻撃飛行隊落下物事故調査概要

Summary of VFA-115 TFOA Investigation

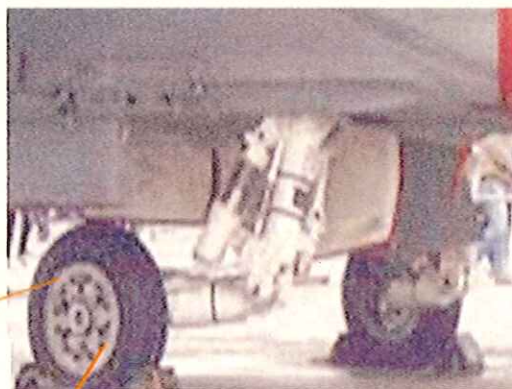
F/A-18E車輪組立て部品

ローター・ドライブ・キーは、車輪が完全に組立てられたとき視認できないことに留意。

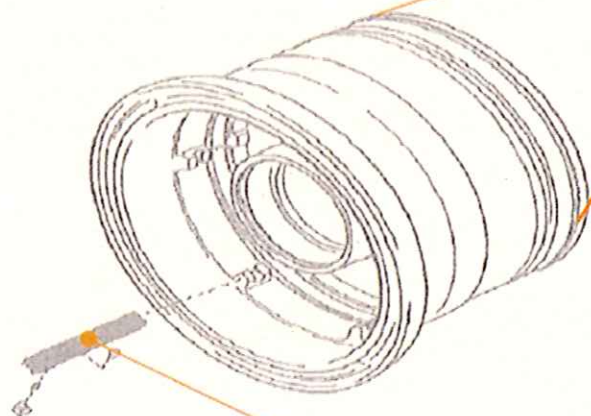
ローター・ドライブ・キー

ローター・ドライブ・キーは、約2cm×17cmの小さな金属製の部品であり、ローターと車輪組立て部品を調節するために設計されたものである。

本事故は、F/A-18E/F及びE/A-18Gのローター・ドライブ・キー組立て部品の設計上の不具合が原因であり、その結果、ローター・キーが緩むに至った。

米海軍航空機部門の航空機が適切に機能することを確保する責務がある米海軍航空システム部隊（NAVAIR）は、この不具合を是正するためにローター・ドライブ・キー組立て部品を変更する技術変更提案を提出した。この提案は、より確実にネジとナットを締め付けるために溝をローター・ドライブ・キーの表面に追加すること、また、それぞれのローター・ドライブ・キーを取替える際、新しい留め具が取り付けられることを義務付けている。新しい設計が承認されれば、本不具合を恒久的に是正するために、飛行隊全てのF/A-18E/F及びE/A-18Gに対し、NAVAIRによるこの変更が実施されることになる。

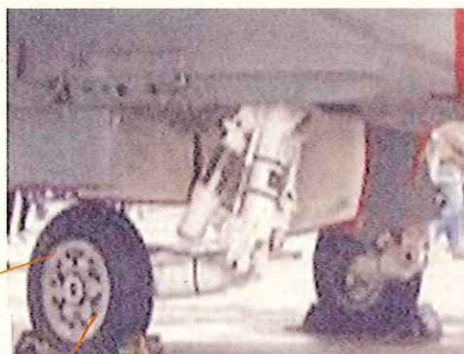
F/A-18E wheel assembly.
Note that the Rotor Drive Key is not visible with the wheel fully assembled.

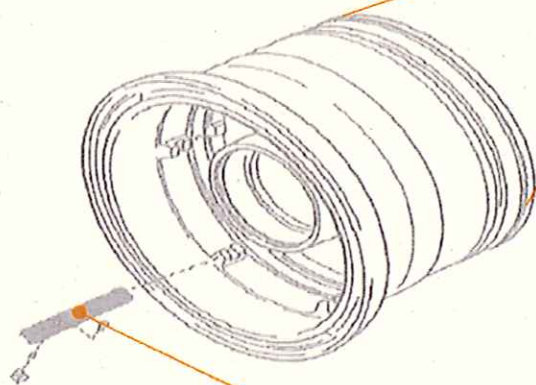
The Rotor Drive Key is a small piece of metal approximately 2cm x 17cm that is designed to align the rotor and wheel assembly.

This incident resulted from a design deficiency in the Rotor Drive Key Assemblies of F/A-18E/F and E/A-18G that allowed the Rotor Key to come loose.

U.S. Naval Air Systems Command (NAVAIR), which is responsible for ensuring the proper functioning of U.S. Naval Aviation aircraft, submitted an engineering change proposal to alter the Rotor Drive Key assembly to correct this deficiency. This proposal will add a groove into the top surface of the Rotor Drive Key to better secure the fastening screw and nut and will also require new fastener hardware be installed during each Rotor Drive Key replacement. Once the new design is approved this alteration will be implemented by NAVAIR for all F/A-18E/F and E/A-18G aircraft fleet wide to permanently correct this deficiency.
