米海軍厚木基地所属F/A-18Eスーパーホーネットからの部品落下に係る
調査報告書について

第115戦闘攻撃飛行隊落下物事故調査概要

Summary of VFA-115 TFOA Investigation

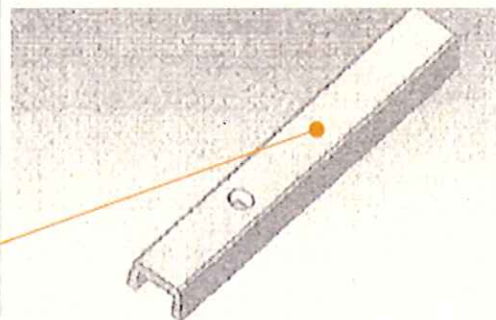
ローター・ドライブ・キー

ローター・ドライブ・キーは、約2cm×17cmの小さな金属製の部品であり、ローターと車輪組立て部品を調節するために設計されたものである。

本事故は、F/A-18E/F及びE/A-18Gのローター・ドライブ・キー組立て部品の設計上の不具合が原因であり、その結果、ローター・キーが緩むに至った。

米海軍航空機部門の航空機が適切に機能することを確保する責務がある米海軍航空システム部隊（NAVAIR）は、この不具合を是正するためにローター・ドライブ・キー組立て部品を変更する技術変更提案を提出した。この提案は、より確実にネジとナットを締め付けるために溝をローター・ドライブ・キーの表面に追加すること、また、それぞれのローター・ドライブ・キーを取替える際、新しい留め具が取り付けられることを義務付けている。新しい設計が承認されれば、本不具合を恒久的に是正するために、飛行隊全てのF/A-18E/F及びE/A-18Gに対し、NAVAIRによるこの変更が実施されることになる。

—影響を受ける車輪組立て部品を航空機中間整備分遣隊 (AIMD) から受領するのに先立ち、飛行隊航空機整備部は、ローター・ドライブ・キーの取り付けについて完全性/安全性の検査を実施し、飛行隊の整備記録に適切に記録することを確実にすることとする。この完全性/安全性の検査は、飛行隊の航空機に車輪組立て部品を取り付けるのに先立ち、実施されなければならない。

—さらに、AIMDは、影響を受けるいかなる車輪組立て部品がF/A-18E又はE/A-18G飛行隊に支給可能となる前までは、ローター・ドライブ・キーの交換に関係する全ての留め具部品を継続的に取替えることとする。

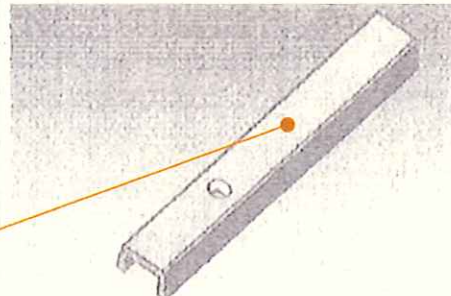
The Rotor Drive Key is a small piece of metal approximately 2cm x 17cm that is designed to align the rotor and wheel assembly.

This incident resulted from a design deficiency in the Rotor Drive Key Assemblies of F/A-18E/F and E/A-18G that allowed the Rotor Key to come loose.

U.S. Naval Air Systems Command (NAVAIR), which is responsible for ensuring the proper functioning of U.S. Naval Aviation aircraft, submitted an engineering change proposal to alter the Rotor Drive Key assembly to correct this deficiency. This proposal will add a groove into the top surface of the Rotor Drive Key to better secure the fastening screw and nut and will also require new fastener hardware be installed during each Rotor Drive Key replacement. Once the new design is approved this alteration will be implemented by NAVAIR for all F/A-18E/F and E/A-18G aircraft fleet wide to permanently correct this deficiency.
